Causal Analysis of the Unanticipated Extremity Exposure at HFEF

Level 1 Cause Analysis

ORPS Number: NE-ID--BEA-HFEF-2011-0004

INL/EXT-11-24112

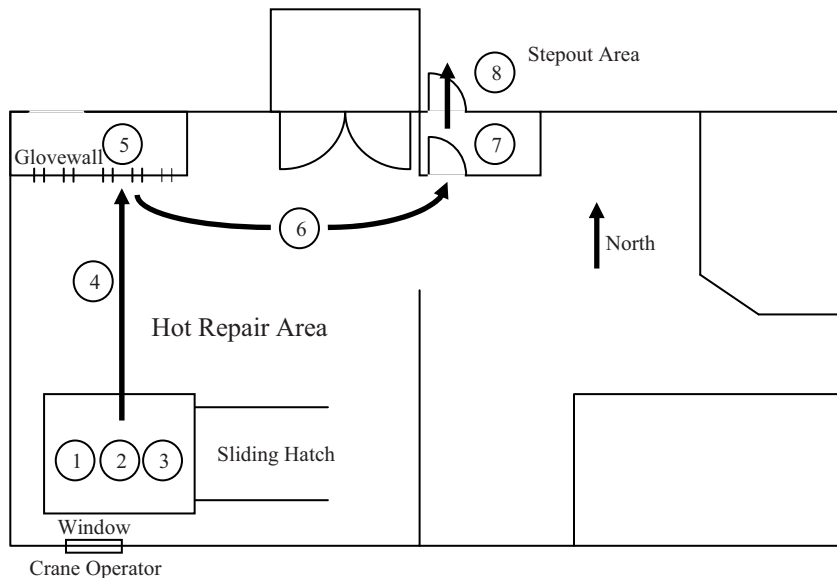
Figure 1. Hot repair area sample handling process flow diagram.

Figure 1 depicts the 8 step process that the samples followed in the HFEF Hot Repair Area concluding with samples being loaded in a small shielded cask (pig). The Crane Operator for these steps was located near the southwest corner of the Hot Repair Area and was in visual contact with the Glove Wall Operator directly across the room at the Glove Wall.

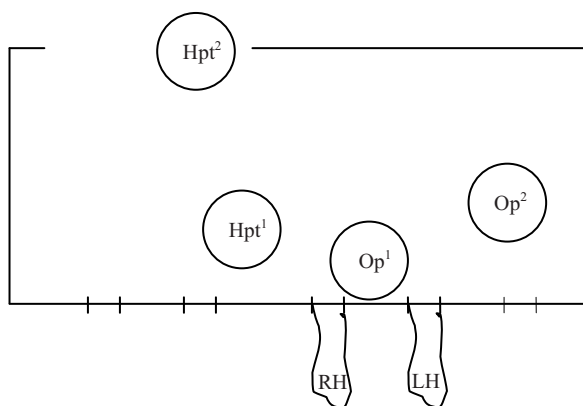
Figure 3. Step 5, Glovewall Room detail with personnel locations.

Op^1 performed a decontamination wipe as required per the FRM-327 on the outside of each sample bag. Then HPT1, with assistance from Op^1 , surveyed for γ and β - γ on each of the samples at 30 cm and on contact, per HFEF-3152, LST-482, and the Radiological Surveys procedure (MCP-139). This was accomplished by pulling the sample into an inverted glove (see Appendix D, Figures 7 and 8) to allow for surveying in the Glovewall Room with a RO20 meter. This survey was the first survey of β radiation levels for these samples.

The RO20 meter indicated off-scale high (*pegged its highest scale, >50 rem/h*) during the survey of the third Met mount sample, 71T. The sample was placed back into the Hot Repair Area and the first two samples were resurveyed on both sides to ensure the survey was performed correctly, on the sample side of the Met mount. At this point HPT¹ instructed the Op¹ to step back from the Glovewall, and called the acting HPT Supervisor, who brought a copy of the Glovewall RWP up to the area. HPT¹, HPT², and the acting HPT Supervisor discussed the situation and reviewed the Glovewall RWP. It was stated that they *determined that no RWP requirements were exceeded, since the Glovewall RWP had no limit for β* . The decision was then made by the acting HPT Supervisor during this meeting to continue working in preparation to transfer the samples to the Electron Microscopy Laboratory (EML). They also decided that they would not survey the samples again at the Stepout Room to minimize exposure to personnel. The Stepout Room RWP (MFC2011130 Rev.03) was not referred to during this meeting. The survey of the fourth Met mount sample was completed after the conclusion of this meeting.

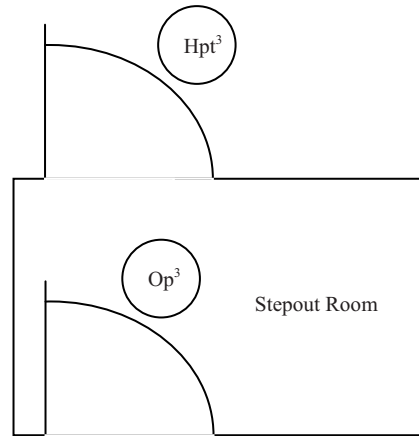
Figure 5. Step 7 and 8, Stepout Room detail with personnel locations.

Operator 3 (Op³) reaches into the Hot Repair Area and takes the transfer bag off of the crane hook and empties the transfer bag onto an uncontaminated bag staged on the floor of the Stepout Room. Op³ then changes his gloves, since the Hot Repair Area is a High Contamination Area (HCA). Op³ then rolls up bag¹ and places it into bag², which was held by HPT³ located in the Radiological Buffer Area (RBA) outside of the Stepout Room. This series of bagging operations is shown in Appendix D, Figures 9, 10, 11, and 12. This step was performed per HFEF-OI-3152, LST-482, and the Performer Controlled Activity List for Laboratory and Hot Cells Services (LST-483).

It was determined by a RadCon Engineer and the MFC RadCon Manager that the extremity exposure most likely occurred at this step in the process while handling Met mount samples 71T, 72T, 74T, and 75T. This was based on a review of the following;

The Operator was informed that the samples were hot. The small pig size required bags to be rolled up. The selected small pig resulted in additional handling time, and rolling up the bag by hand decreased distance to the hazard. Had a pig been selected with a larger interior that did not require rolling up the bag this event may have been prevented.
